# CONSERVATION OF A 1929 WALTHAM 9 TUBE HALL CLOCK

Technical Case Study | Village Time & Tide

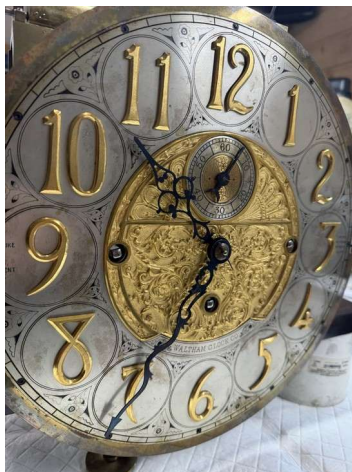
Ornate Waltham dial and subsidiary seconds register.

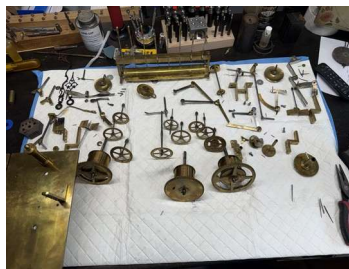
Complete disassembly permits inspection of every train and control component.

The movement was completely disassembled so every wheel, arbor, pivot, pinion, lever, and related component could be evaluated individually. Each pivot was reviewed for wear, surface condition, and proper geometry, while every wheel and pinion was closely examined under a stereo microscope to verify that teeth, pivots, and working surfaces remained structurally sound and fit for continued service. All components then passed through a controlled soft-cleaning wash, followed by thorough rinsing and careful drying. After cleaning, final inspections were performed before wear determinations were made. Bushing work and other corrective intervention were limited only to essential worn locations where proper alignment, freedom of movement, or reliable operation could no longer be maintained. Where repair was necessary, the goal was to preserve original material and make the intervention visually sympathetic to the original construction - correcting the mechanical deficiency without leaving the movement looking unnecessarily altered or modern.

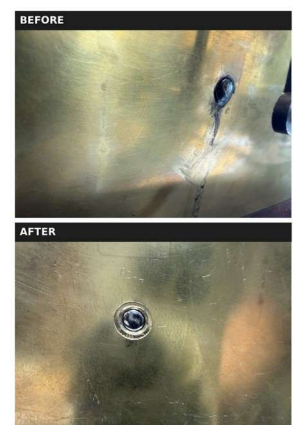
Inspection revealed wear within the movement consistent with long service, together with evidence of earlier intervention. Particular attention was required at bearing surfaces and high-load points within the trains. The movement also showed historic tool marks and identification scratches on the plates. These were documented rather than erased: they form part of the object's service history, even when they do not reflect ideal conservation practice.

Before and after localized plate repair.
